Debris/Ice/TPS Assessment and Integrated Photographic Analysis for Shuttle Mission STS-60

DEBRIS/ICE/TPS ASSESSMENT
AND
INTEGRATED PHOTOGRAPHIC ANALYSIS
OF
SHUTTLE MISSION STS-60

February 3, 1994

Shuttle Mission STS-60 was launched at 7:10 a.m. local 2/3/94

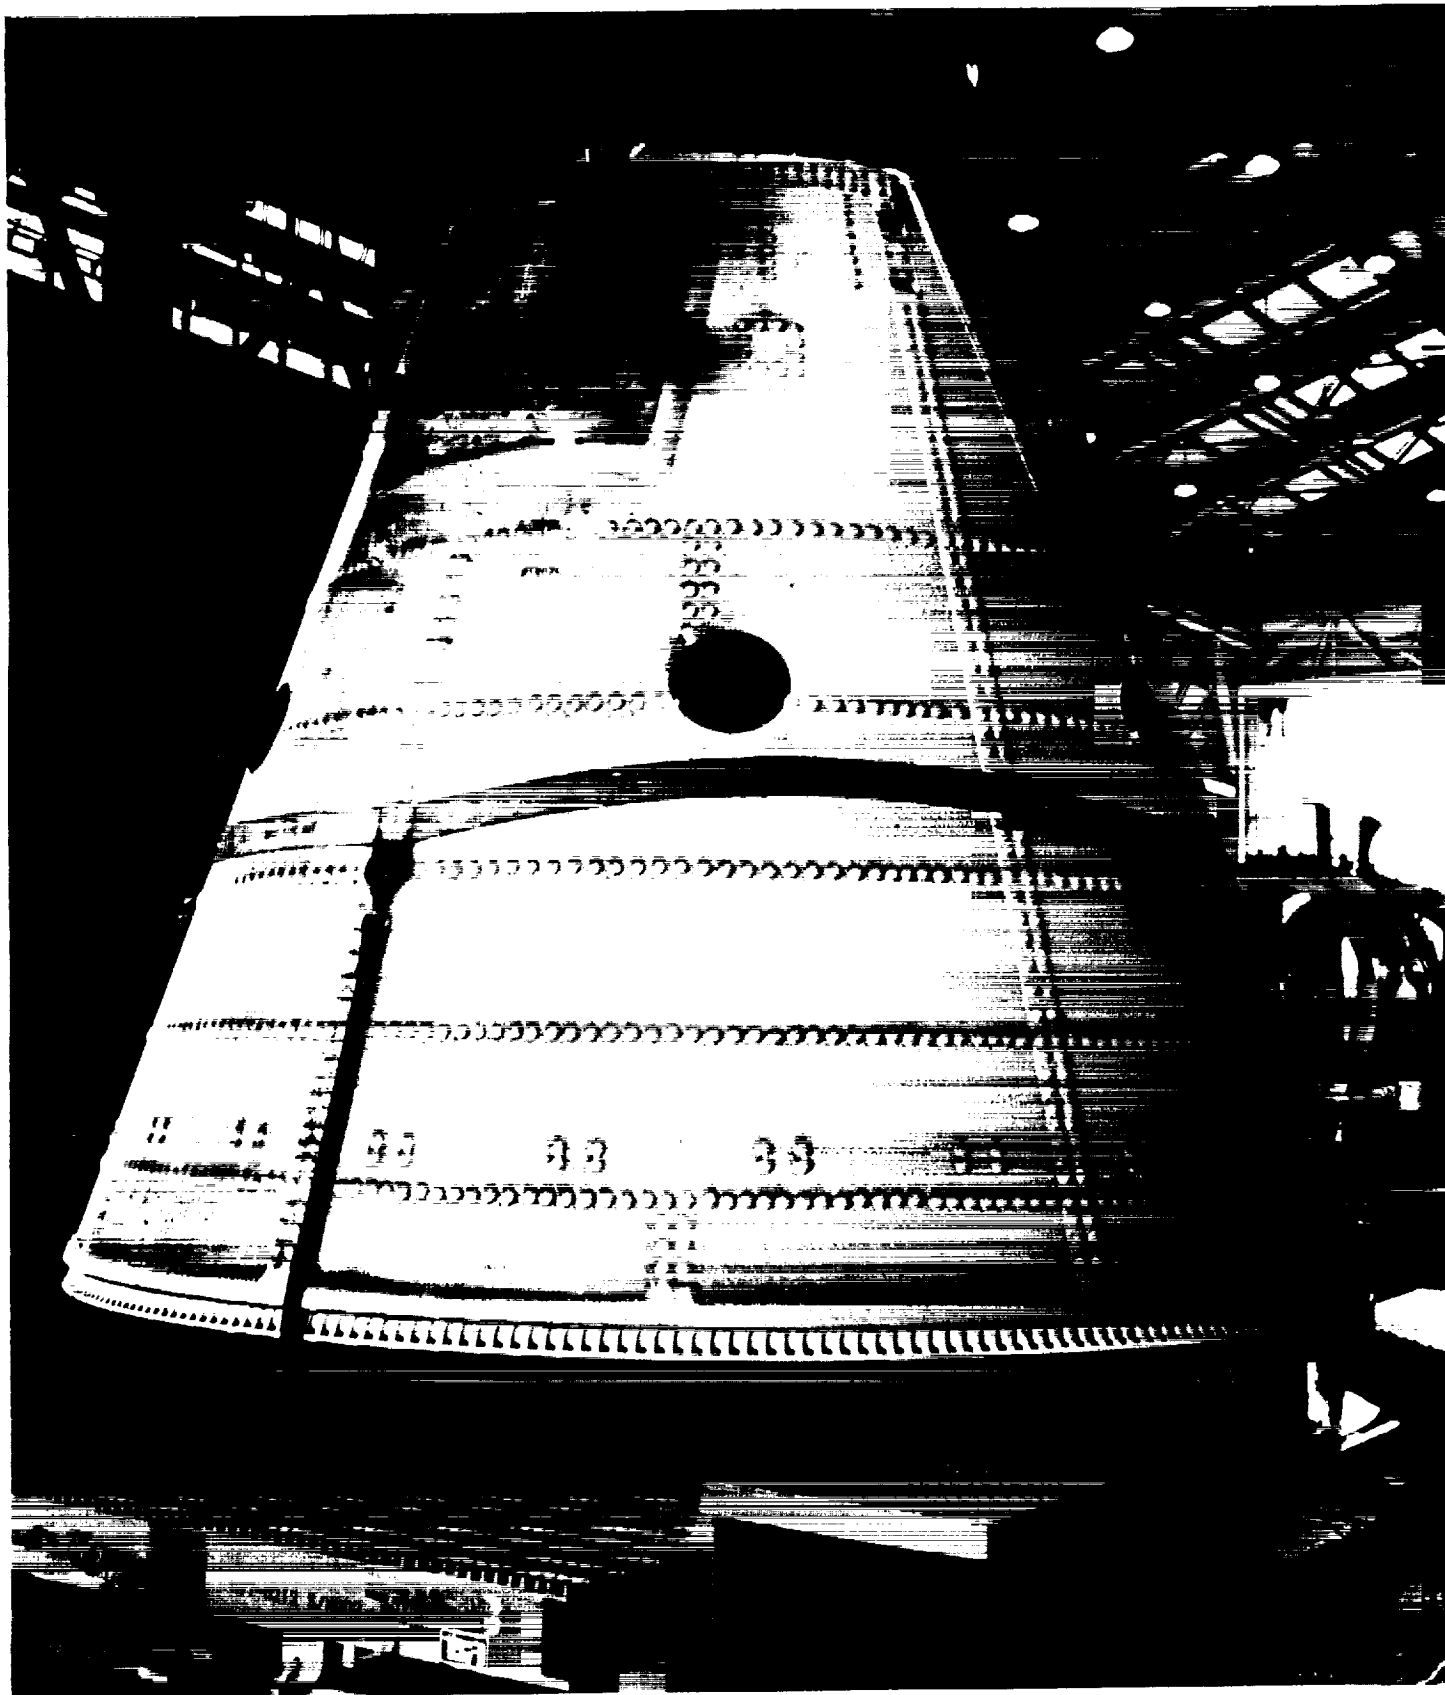
The LH frustum was missing no TPS, but had a total of 11 MSA-2 debonds over fasteners. All BSM aero heatshield covers had locked in the fully opened position, though the upper right cover attach ring had been bent by parachute riser entanglement

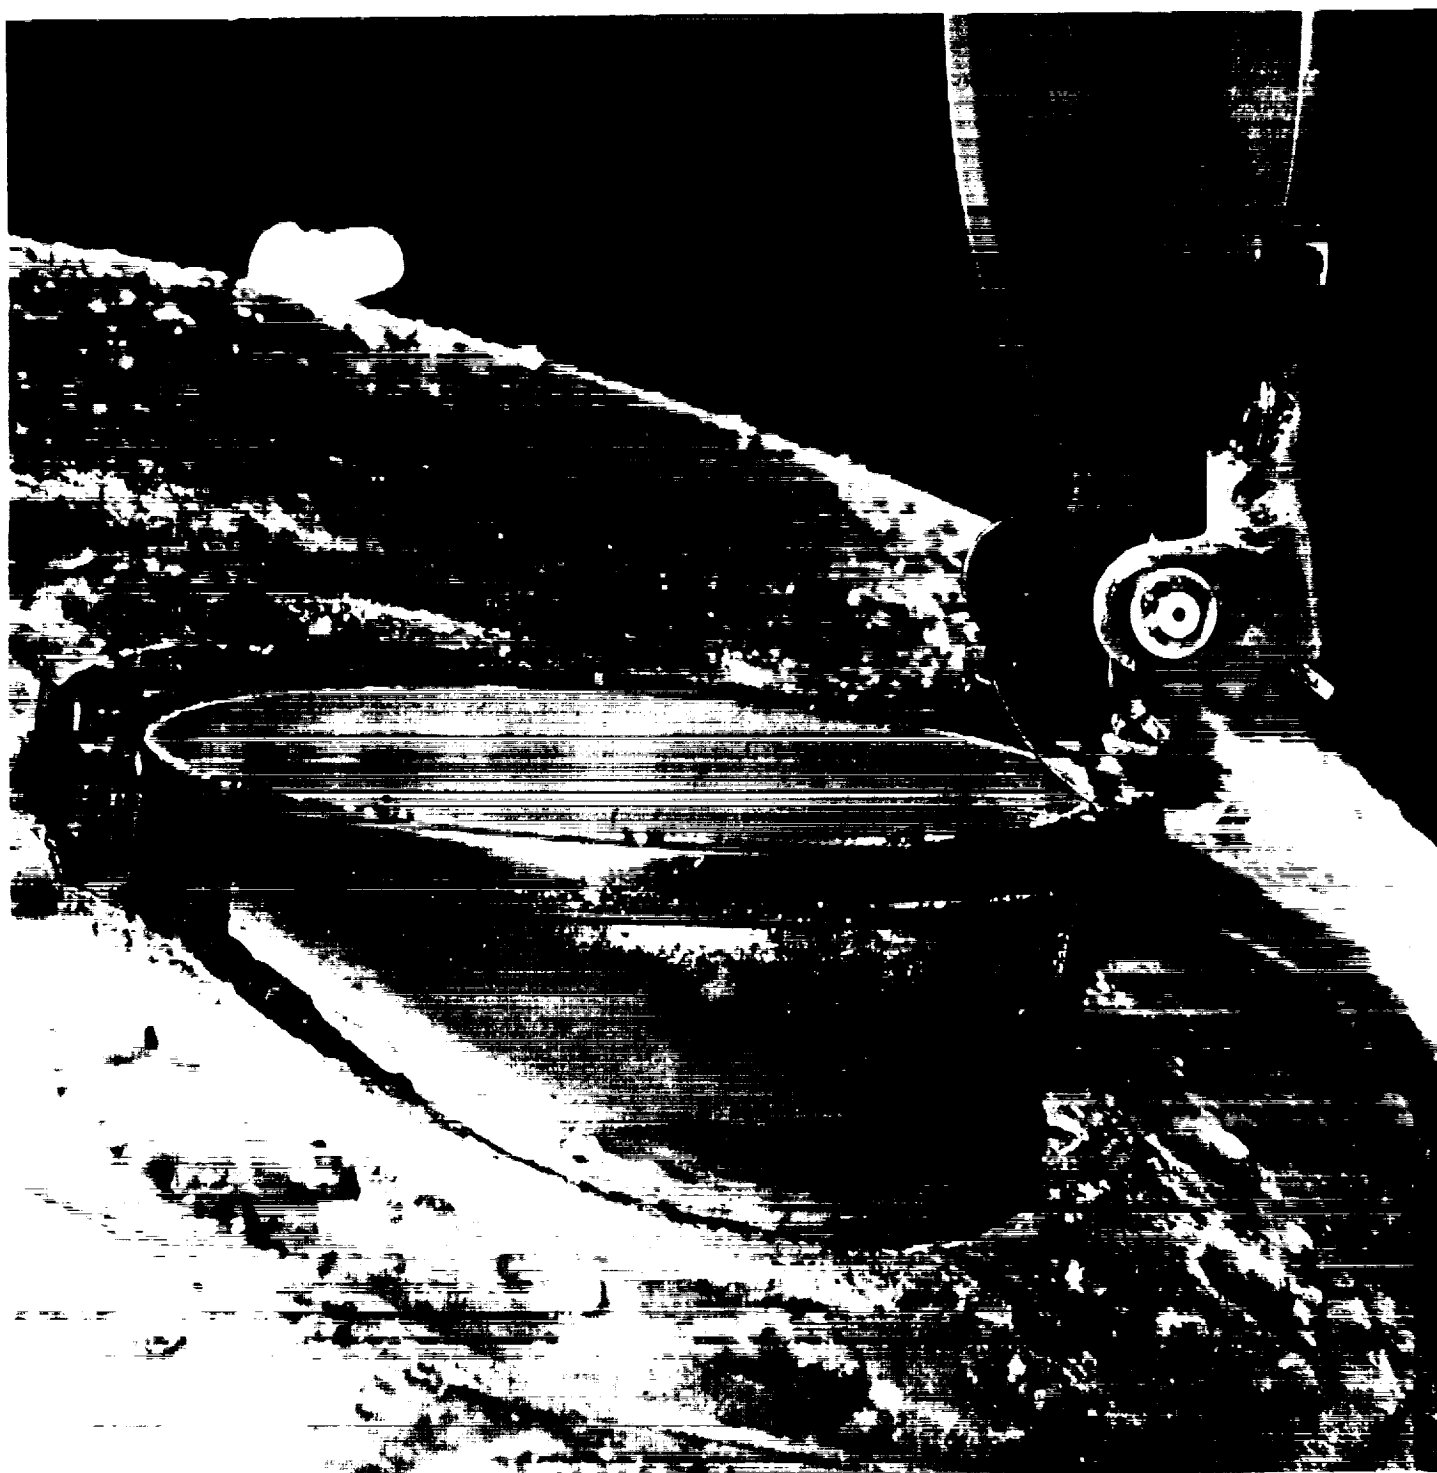
Preliminary post flight assessment revealed the upper right BSM aero heat shield cover had opened and locked properly. The cover was bent back to the 90 degree position. The fracture plane on the cover attach ring was not sooted and may indicate the failure occurred late in re-entry or at water splashdown.

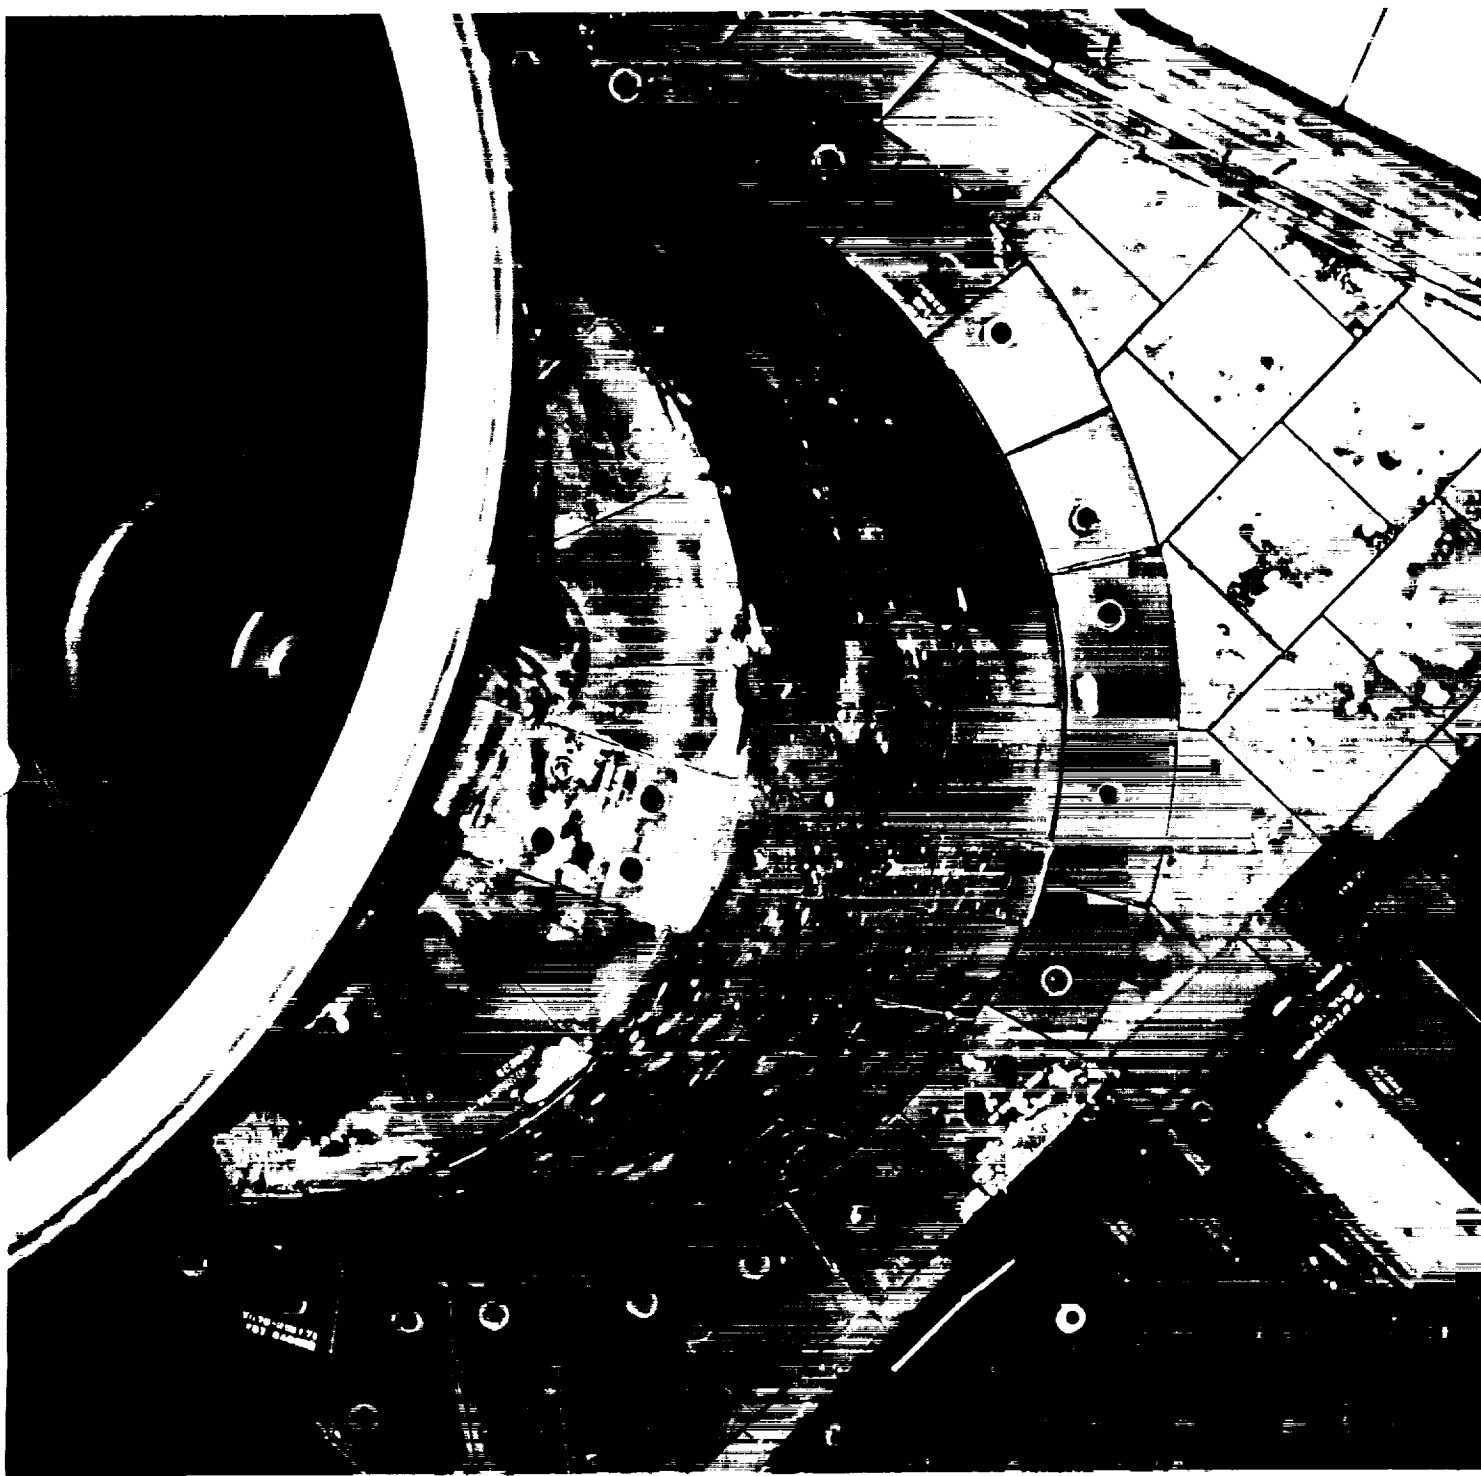
Tile surface coating material was lost from numerous places
on the base heat shield and RH OMS nozzle heat shield

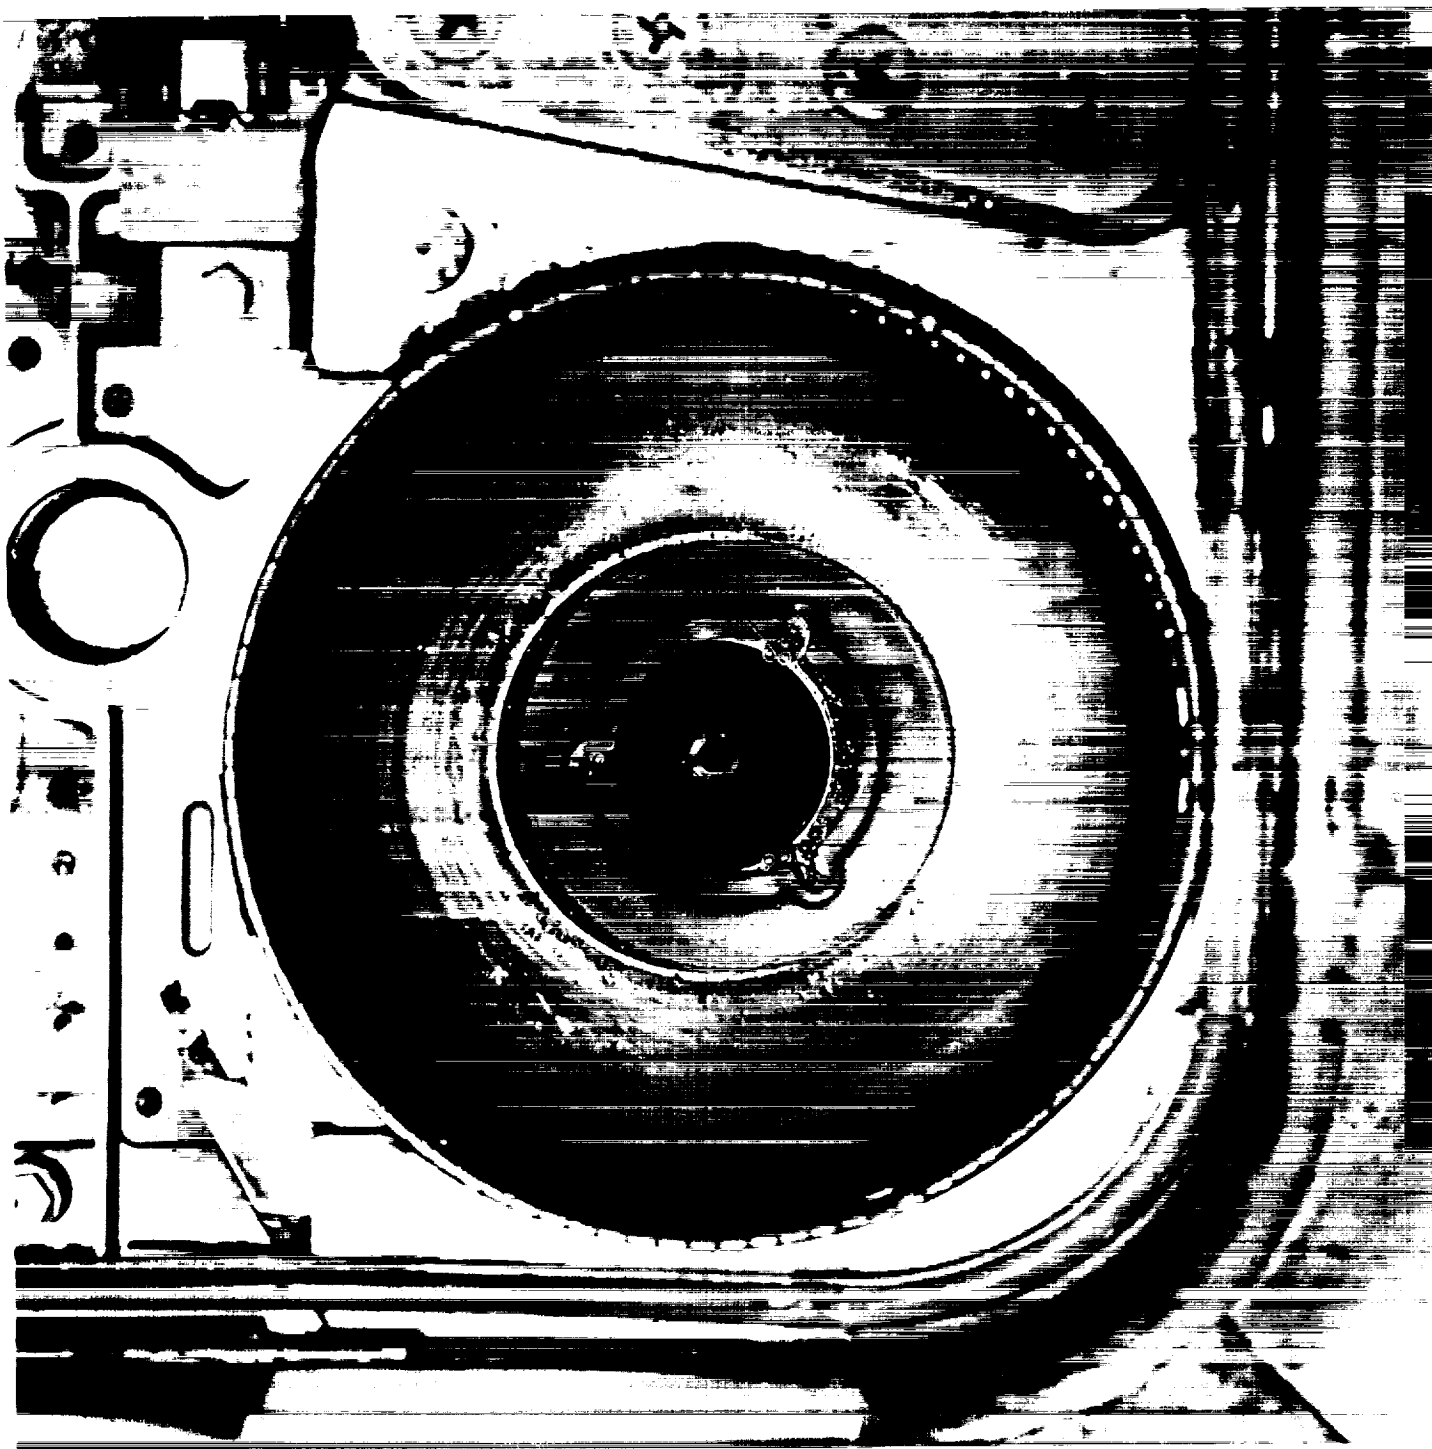
The shim in the EO-2 "salad bowl" was partially debonded and displaced across the stud hole approximately 1/4 inch
